# Book A Builder Building Survey Report

**Date of inspection:** January 23, 2026

**Scope of inspection:** The scope of the inspection is as set out in our Terms and Conditions and is limited to a visual Pre-Purchase, or Pre-Sale inspection, carried out in accordance with NZ4306:2005

**Report number:** 23-01-1155.

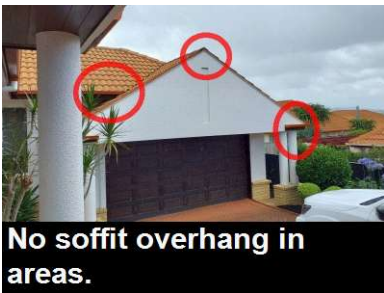
#### PHOTO 3

No soffit overhang in areas, The fascia has been installed prior to the texture coating, which is a recognized weathertightness risk area.

The fascia has been installed prior to the texture coating, which is a recognized weathertightness risk area.

**No soffit overhang in areas.**

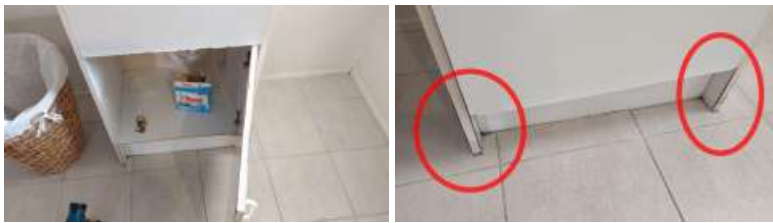
Meltica. There is moisture damage, this tested dry at the time of the inspection and appears to be still serviceable.

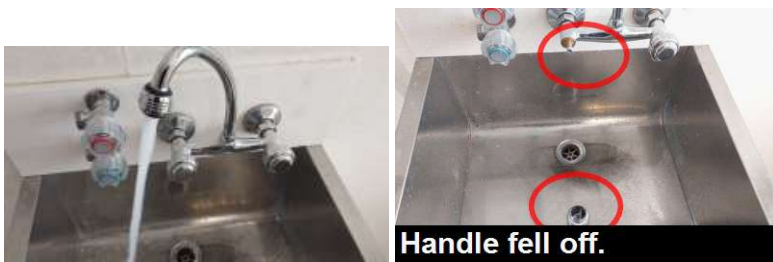
When turning the tap off the handle came off.

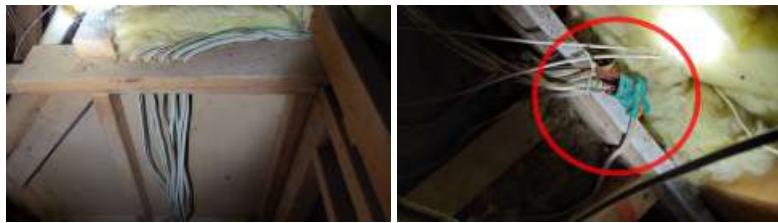
TPS cable. There is some electrical wiring that may be obsolete, and we recommend it be inspected by a registered Electrician. Any obsolete wiring should be removed or terminated correctly.

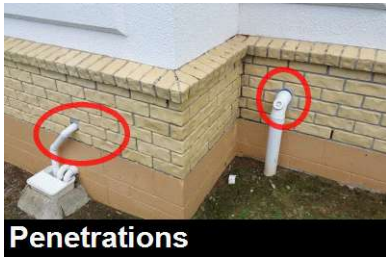
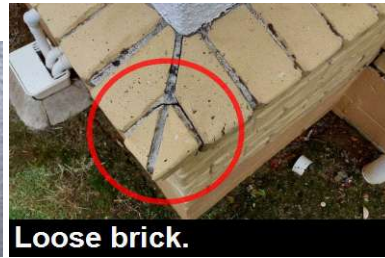
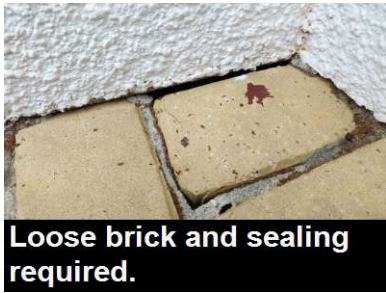
Brick. Any pipes or cables penetrating the exterior cladding should be sealed around to prevent moisture getting in behind the cladding. We have identified the odd loose brick that can be repaired by a qualified tradesperson. You may wish to seal any gaps between the plaster and brick work, to prevent any moisture ingress.

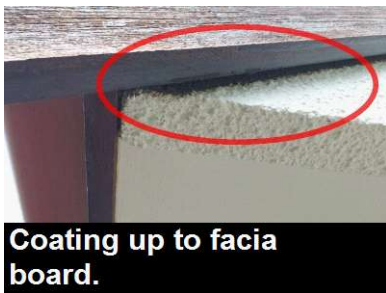
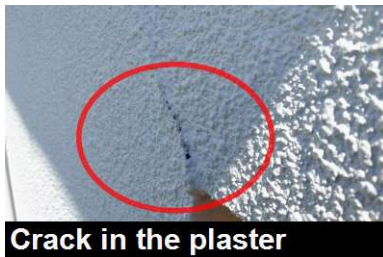
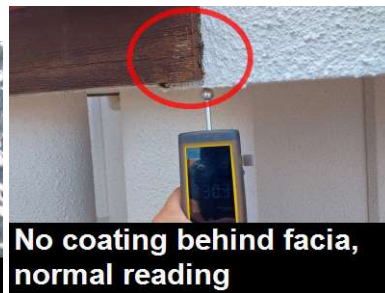
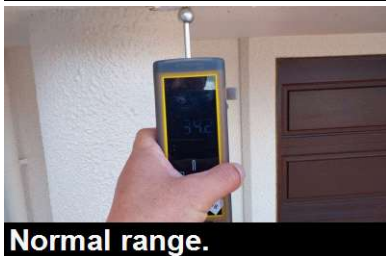
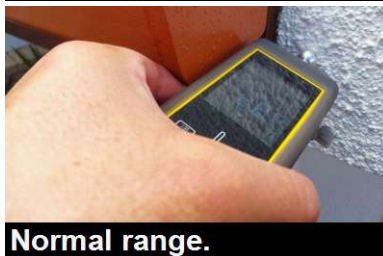
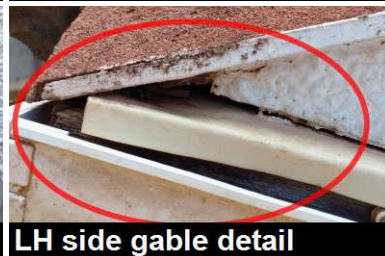
There are cracks in the exterior cladding, which need to be professionally repaired, as any cracks can allow moisture in behind the cladding and into the internal framing. There are textured polystyrene mouldings around the home, these can be weathertightness risk areas and we recommend they be professionally repaired by a cladding specialist.

The Left hand side of the gable over the garage is deteriorating and we recommend to get a licenced builder to give you some options for repair to ensure protection from water ingress.

**Junction needs sealing.**

We recommend this be modified to lower the risk.

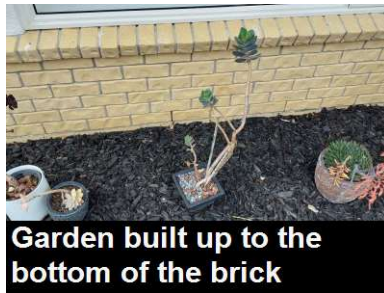
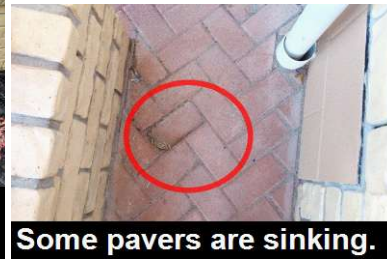
Concrete. The garden on the left hand side of the house has been built up to high against the cladding, which can lead to moisture penetration into the concealed framing. They could be lowered away from the cladding, a landscaper could help you with this.

Paver/tile. A few pavers are sinking, these could be lifted, filled and re fitted.

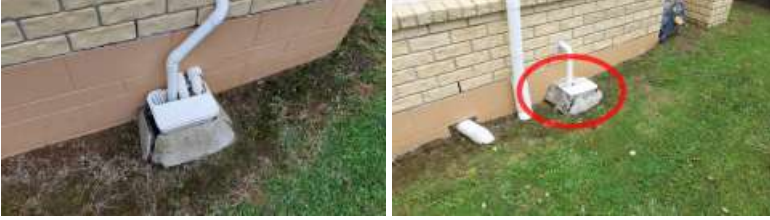
Location. Back of home. The concrete surround has cracked around the gully traps, this could be repaired by a drain layer but does not appear to be urgent.

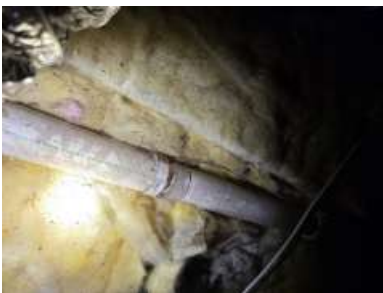
Garage. The pipe in the ceiling has come apart.

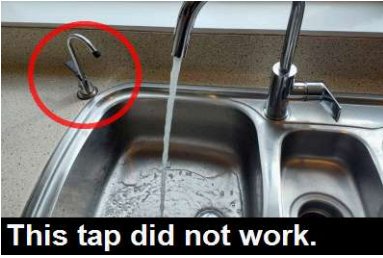
No signs of any current leaks at the time of the inspection.  
I could not get the smaller tap to work.
